SECTION 6: FINDINGS AND CONCLUSIONS

SECTION 7: PHOTOGRAPHIC ESSAY

Appendix A: Initial Assessment Photographs

Project 27720014. Long Beach, CA. topographic map

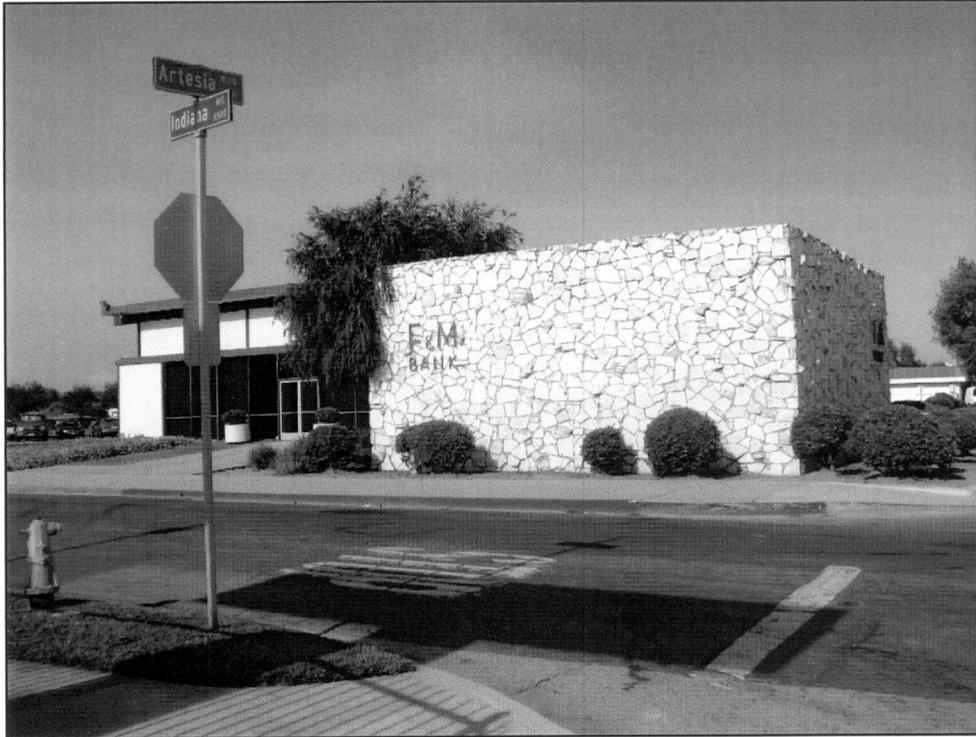
1) East-northeastern elevation of the vault section of the Bank. Note the walls clad in sawn rock typical of post-War commercial styling. Door behind sign originally opened into the Dairy Room.

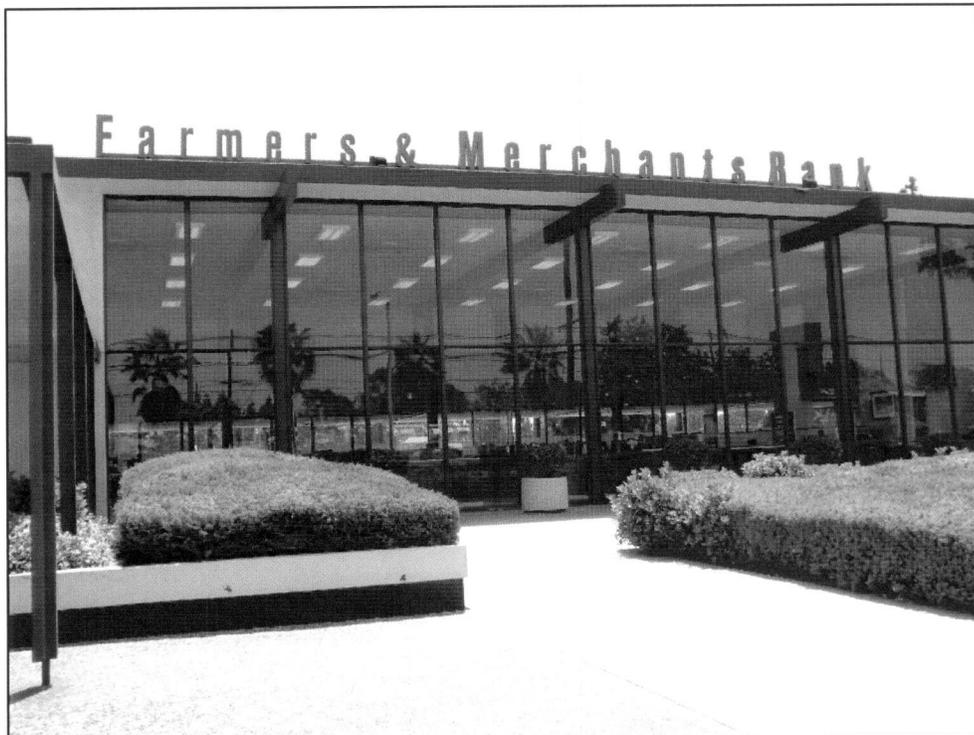
2) North elevation of Bank showing wooden letters atop roof

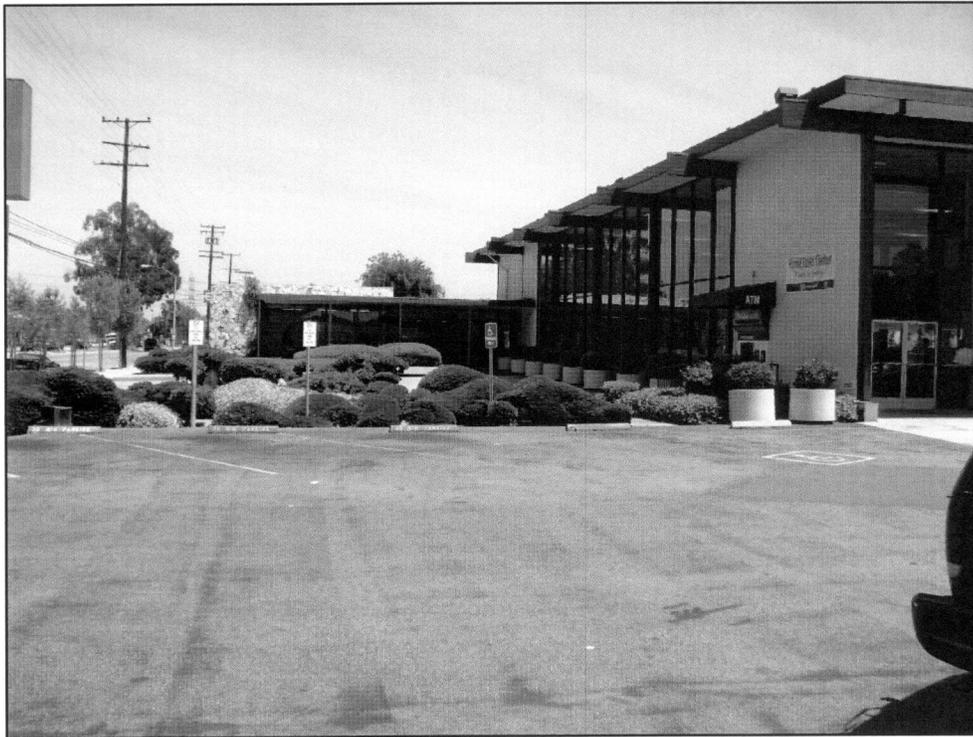
3) View of Bank structure and landscaping toward the east. The lot size and parking are unchanged from 1962.

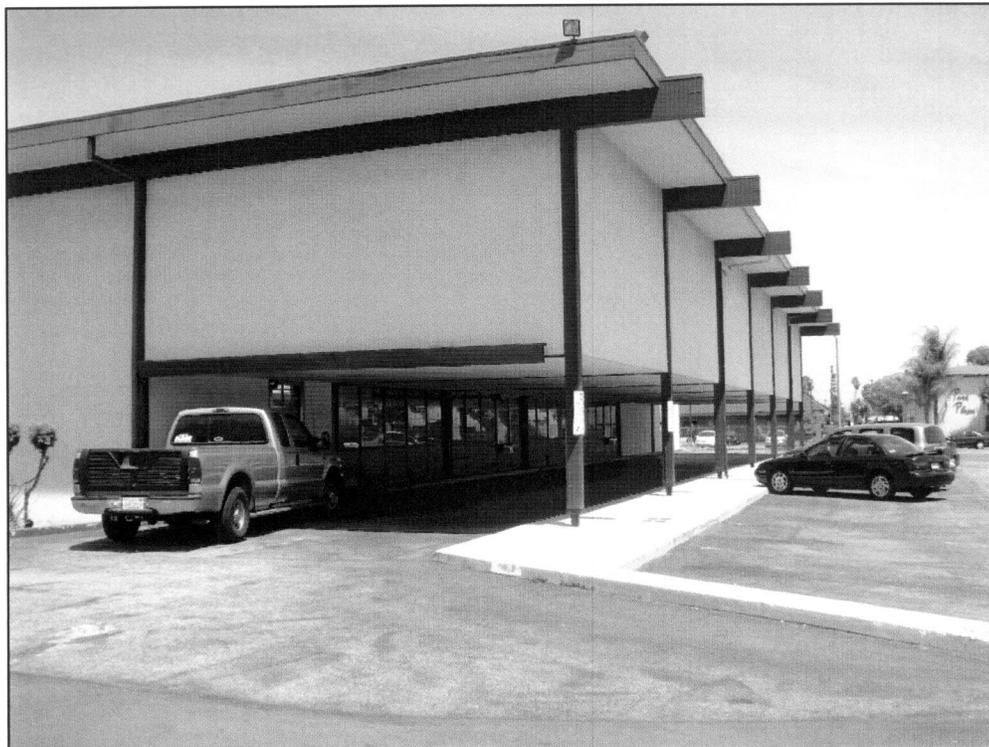
4) View of the extension of the south façade into a drive-in teller lane. Green-painted elements are mostly metal clad in wood showing the primary structural mechanisms. Large trusses extending out from the roof are composite glued wood beams, which were a new innovation in 1962.

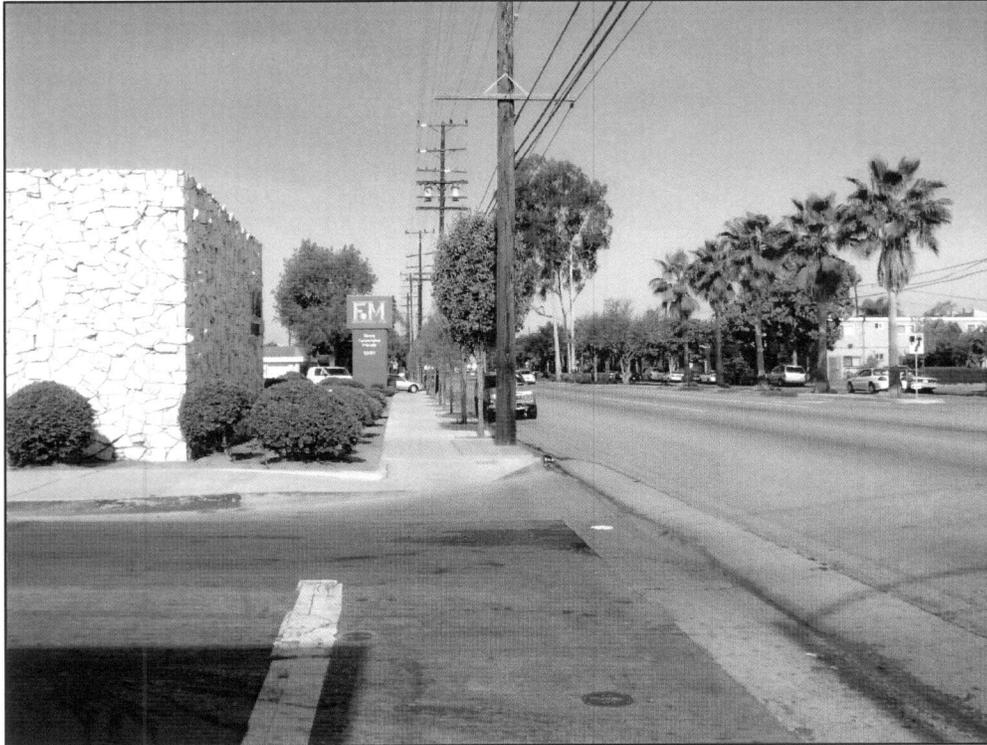
5) View of Artesia Boulevard toward the west. The Edison power line pole right of way can be noted on the earliest aerial photos, and it appears the Artesia Boulevard was developed using land bordering the south side of the street. Two lanes were added after the War.

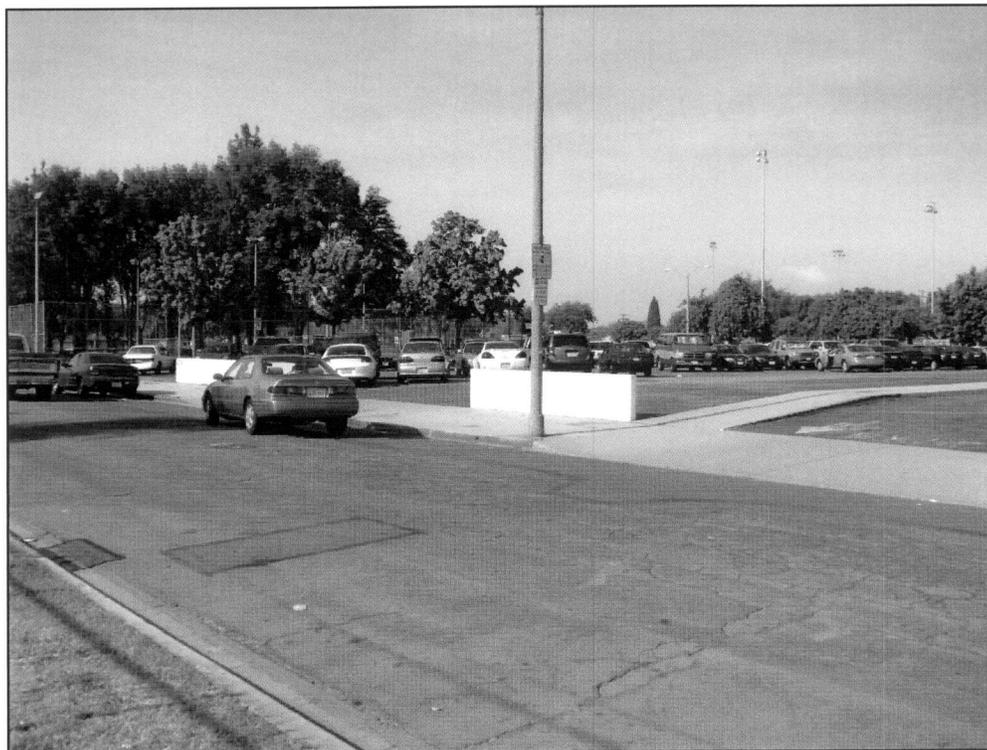
6) Southern parking and Ramona Park. The farm houses in the 1947 aerial photo would have been placed in an area where the large trees are located now.

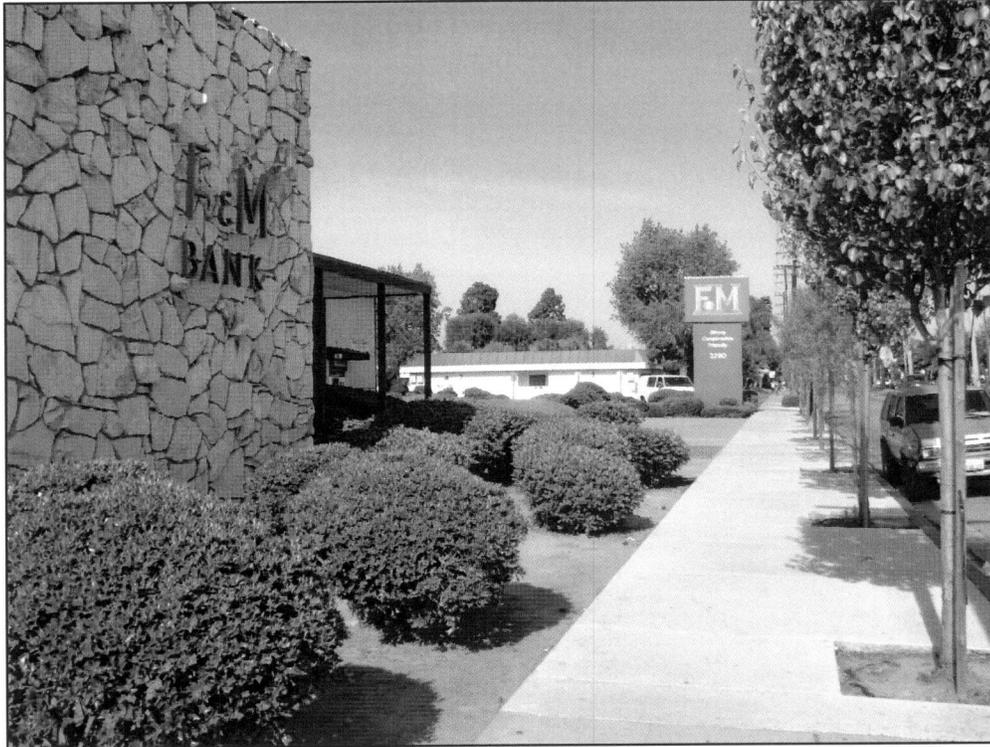
20) Streetside view of the F&M Artesia Branch.

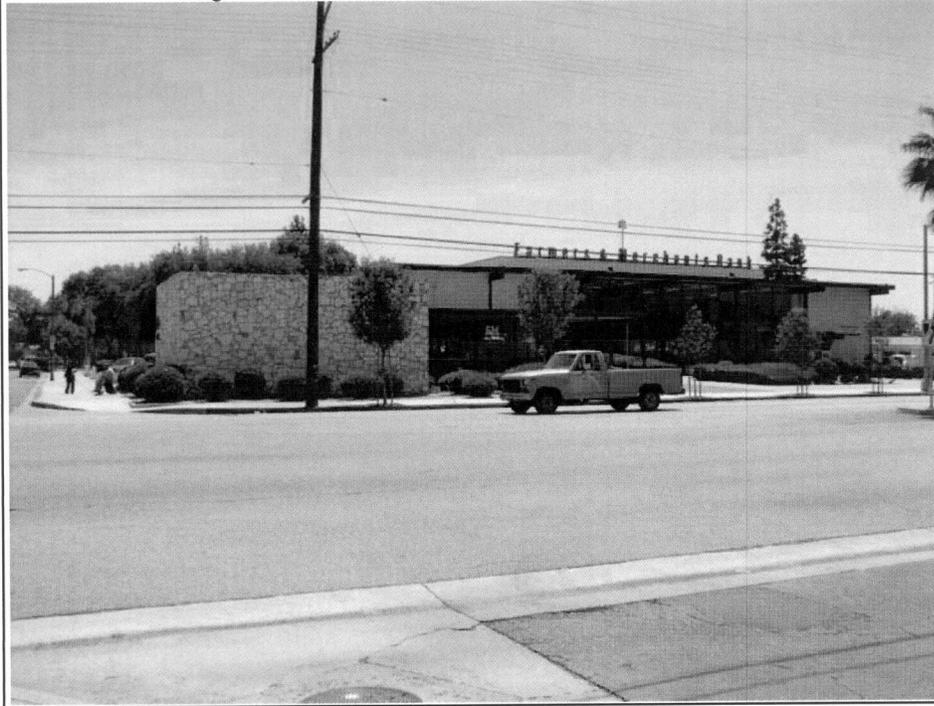
P5a. Photo or Drawing

P5b. Description of Photo: (View, date, accession #) View of the north façade of the Bank at 3290 Artesia Boulevard. May 5, 2009.

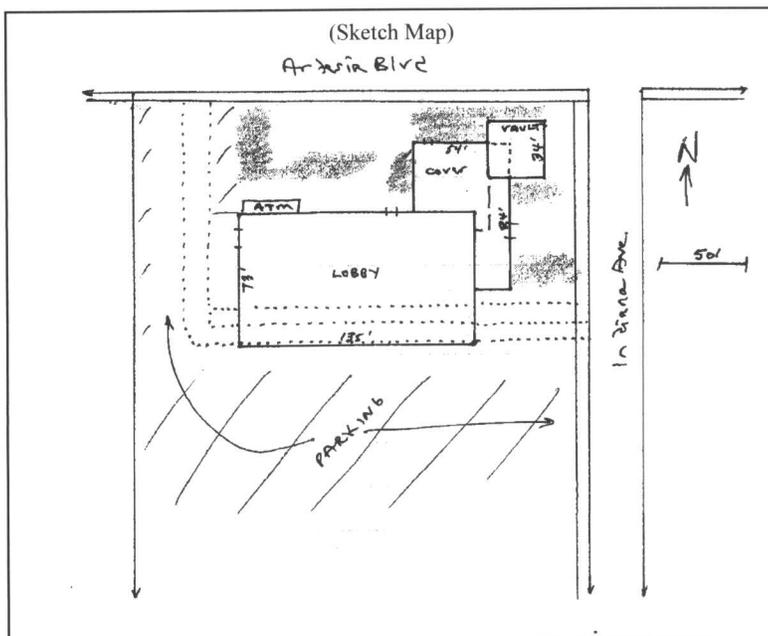
The sketch map reveals the relationship between the major structural elements, the street, the landscaping and parking. Scale shown is 50', north is up.
